MAMMOTH LAKE DAM

NDI I.D. NO: PA-466

PHASE I INSPECTION REPORT
NATIONAL DAM INSPECTION PROGRAM

MAMMOTH LAKE DAM
NDI I.D. NO. PA-466
APRIL 9, 1979

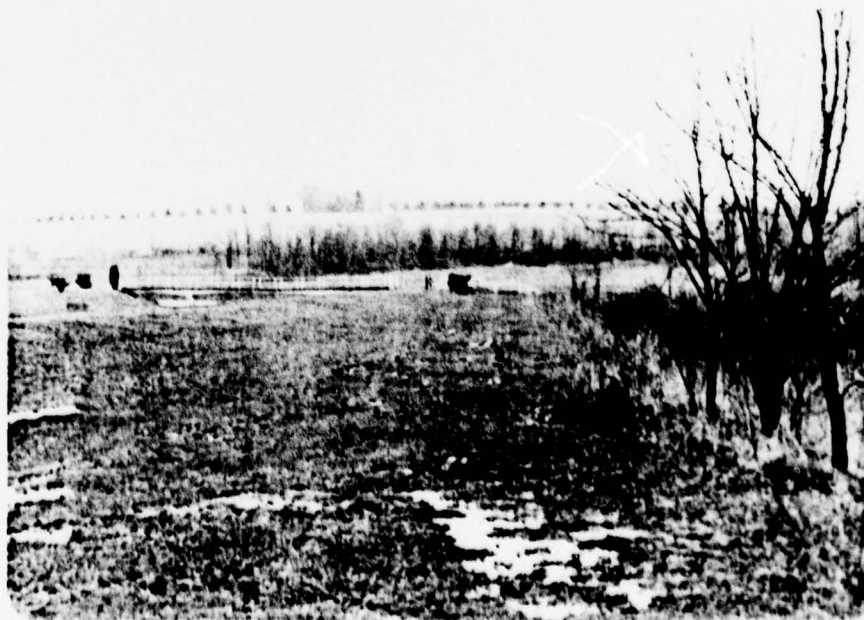
Downstream Face

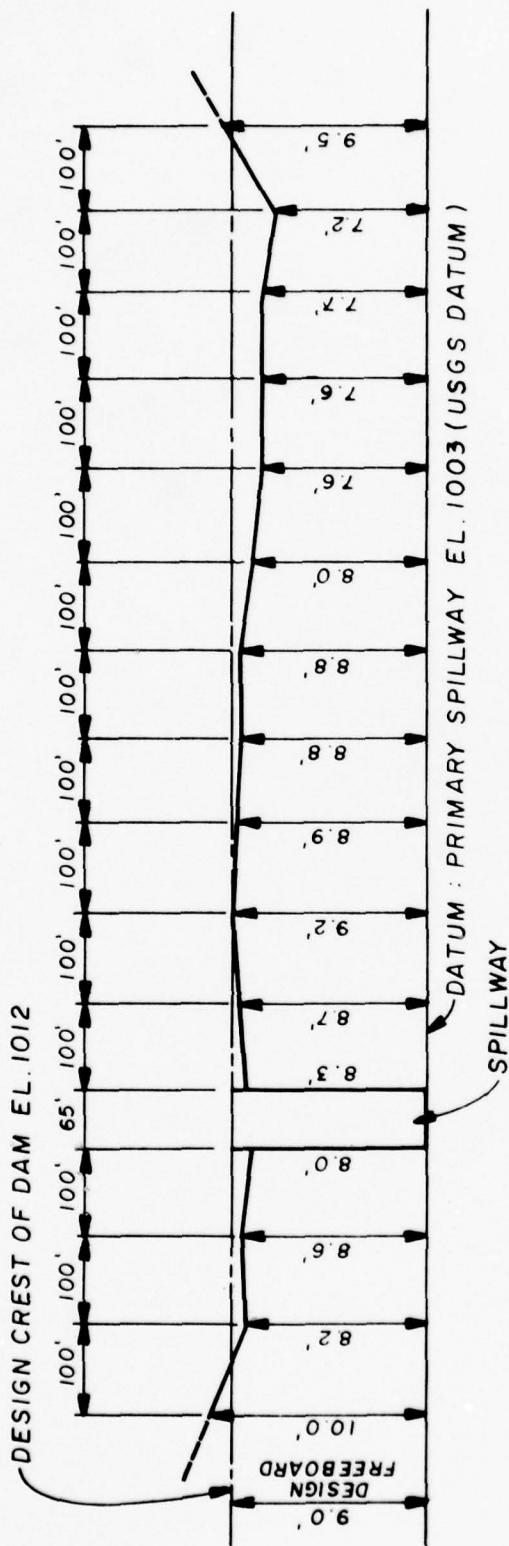
DAM CREST PROFILE (LOOKING DOWNSTREAM)

1. POOL LEVEL DATE OF INSPECTION: 0.2 FEET ABOVE SPILLWAY CREST
2. SPILLWAY FREEBOARD (MIN.): 7.2 FEET

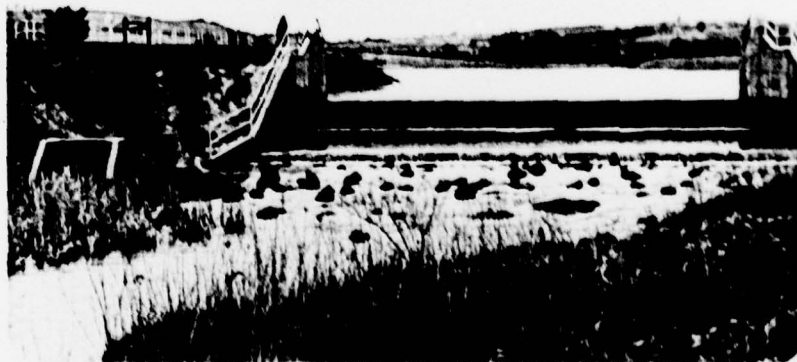
Photograph No. 2
Spillway. Outlet works discharge structure
left of center.

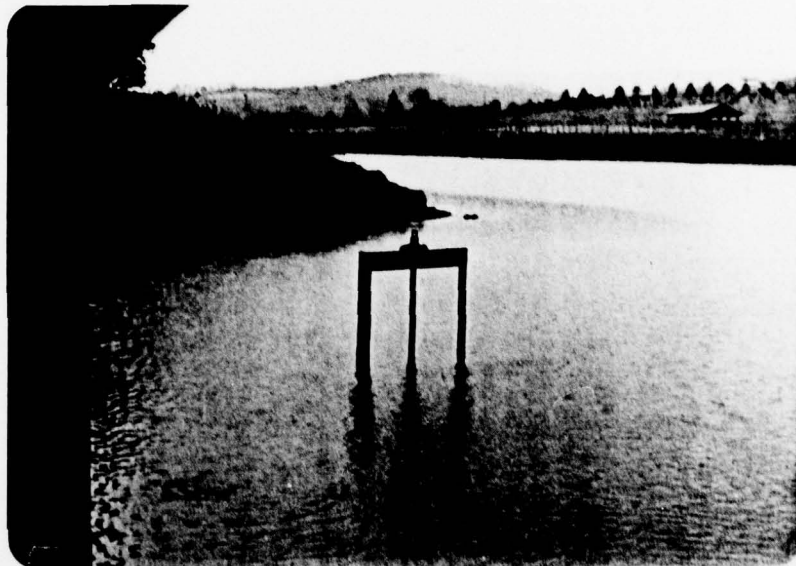
Photograph No. 3
Outlet pipe gate stem.

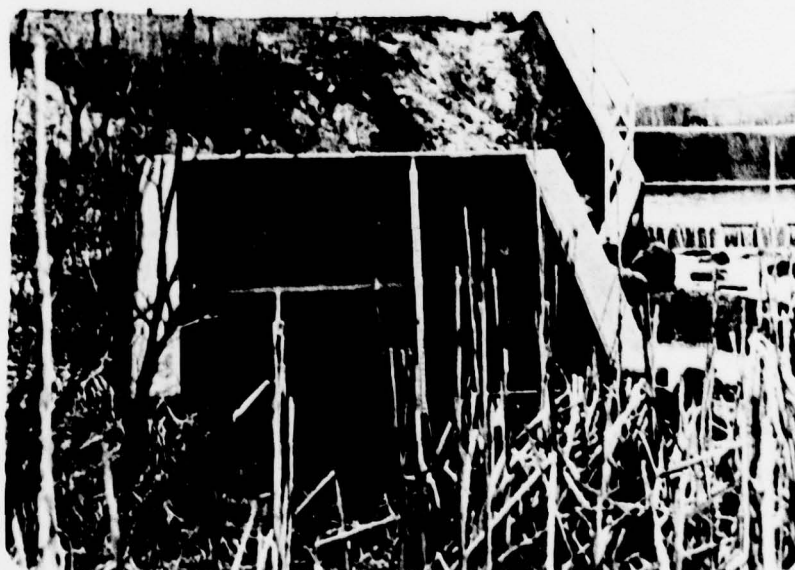
c. Appurtenant Structures. The appurtenant structures were examined for deterioration or other signs of distress and obstructions that would limit flow. Both the spillway and the outlet works structures were found to be structurally in good condition. The outlet pipe stilling basin was found to be blocked by rocks and debris apparently placed by vandals.

4.3 Maintenance of Operating Facilities. The only operational feature of the dam is the reservoir outlet sluice gate, which is operated by a hoist located within the lake. The stilling basin at the downstream end of the outlet pipe was found to be blocked with rocks and debris apparently placed by vandals. The operational condition of the sluice gate was not observed. The gate hoist is accessible by boat only.

Photograph No. 4
Outlet pipe discharge structure. Note debris
blocking the structure.

3.2 Evaluation. The condition of the dam is considered to be good. Filling of the erosion ditches on each side of the spillway and cleaning of the outlet conduit stilling basin is recommended.

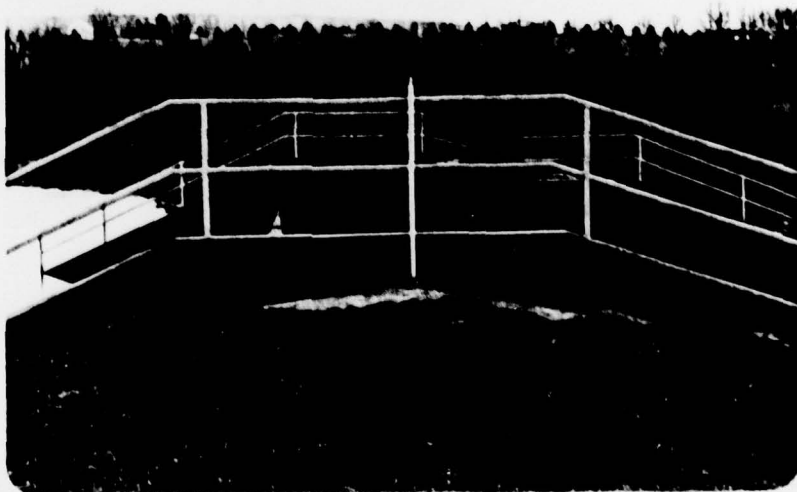
In general, the condition of the dam is considered to be good. Two erosion ditches were located on each side of the spillway structure on the downstream face of the dam. A portion of the upstream slope on the right side of the spillway structure was found to be eroding due to wave action. The top of the embankment was surveyed relative to the spillway crest and was found to be generally below the design crest elevation. The low area occurred near the right abutment. The dam crest profile is illustrated on Plate 13.

Photograph No. 6
Erosion on crest (adjacent to spillway structure only).
